# GREEN SWAMP NO.4 DAM

## PHASE I INSPECTION REPORT

### NATIONAL DAM SAFETY PROGRAM

NJ 00212

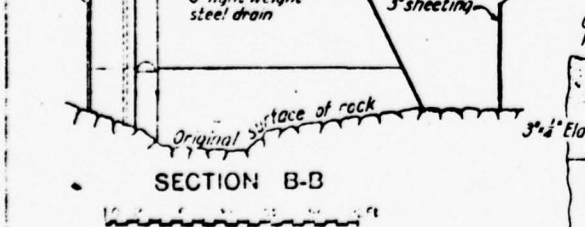
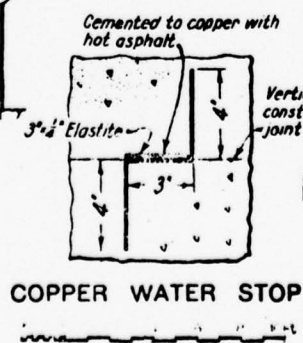
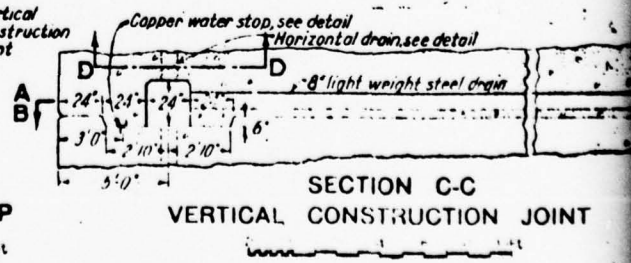
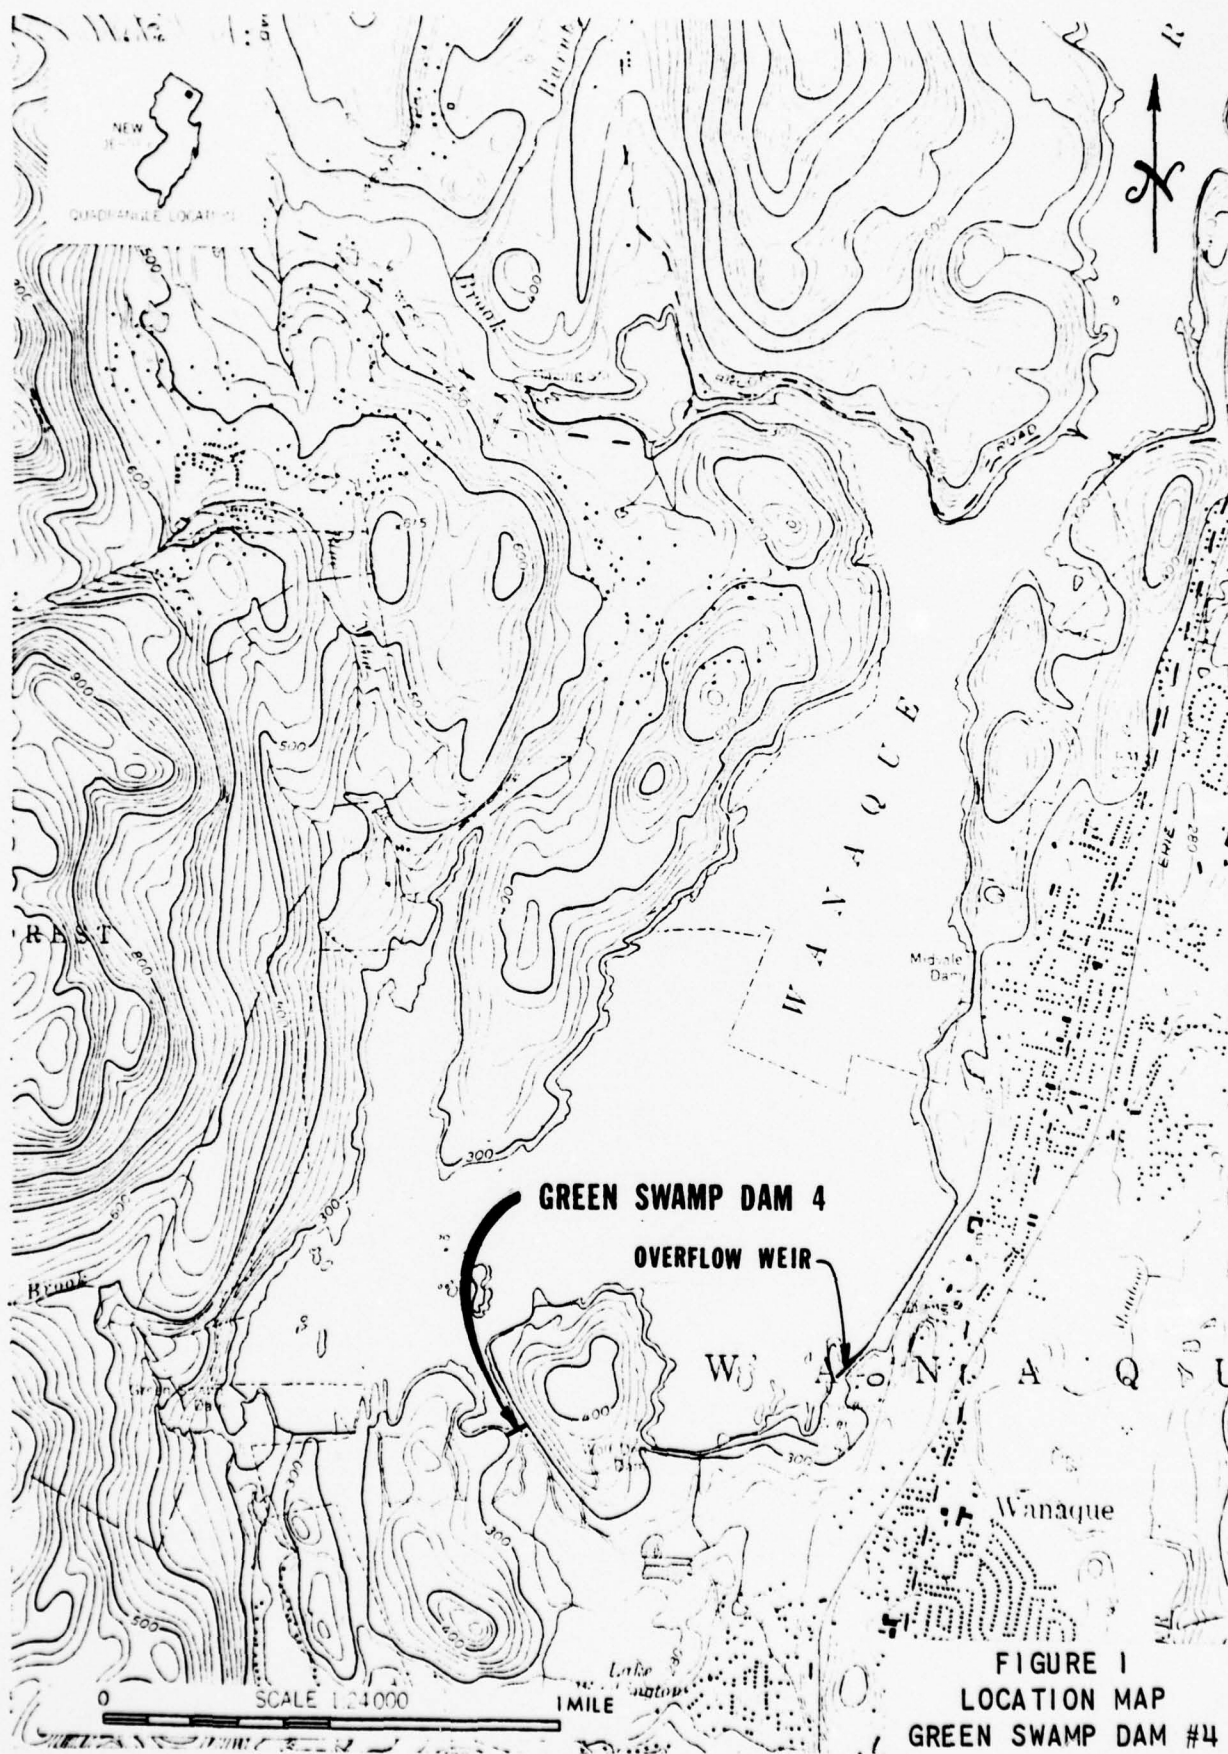
FIGURE 2

A plan, profile, grouting record, and maximum section through the dam are shown on original record tracings which are on file at the NJDWSC engineering office (Mr. Dean C. Noll) at Wanaque, N.J. (See Figure 2). No original design data were available other than results mentioned in the North East Water Works Association publication (Reference 3) and a 1925 report (Reference 2) by the Commissioner of the NJDWSC.
